Inspection by the Invasive Species Program

Lake: Demontreville/Olson

Date of inspection: June 15, 2009

Type of inspection: Delineation of EWM for the EDRR/Nuisance grant program

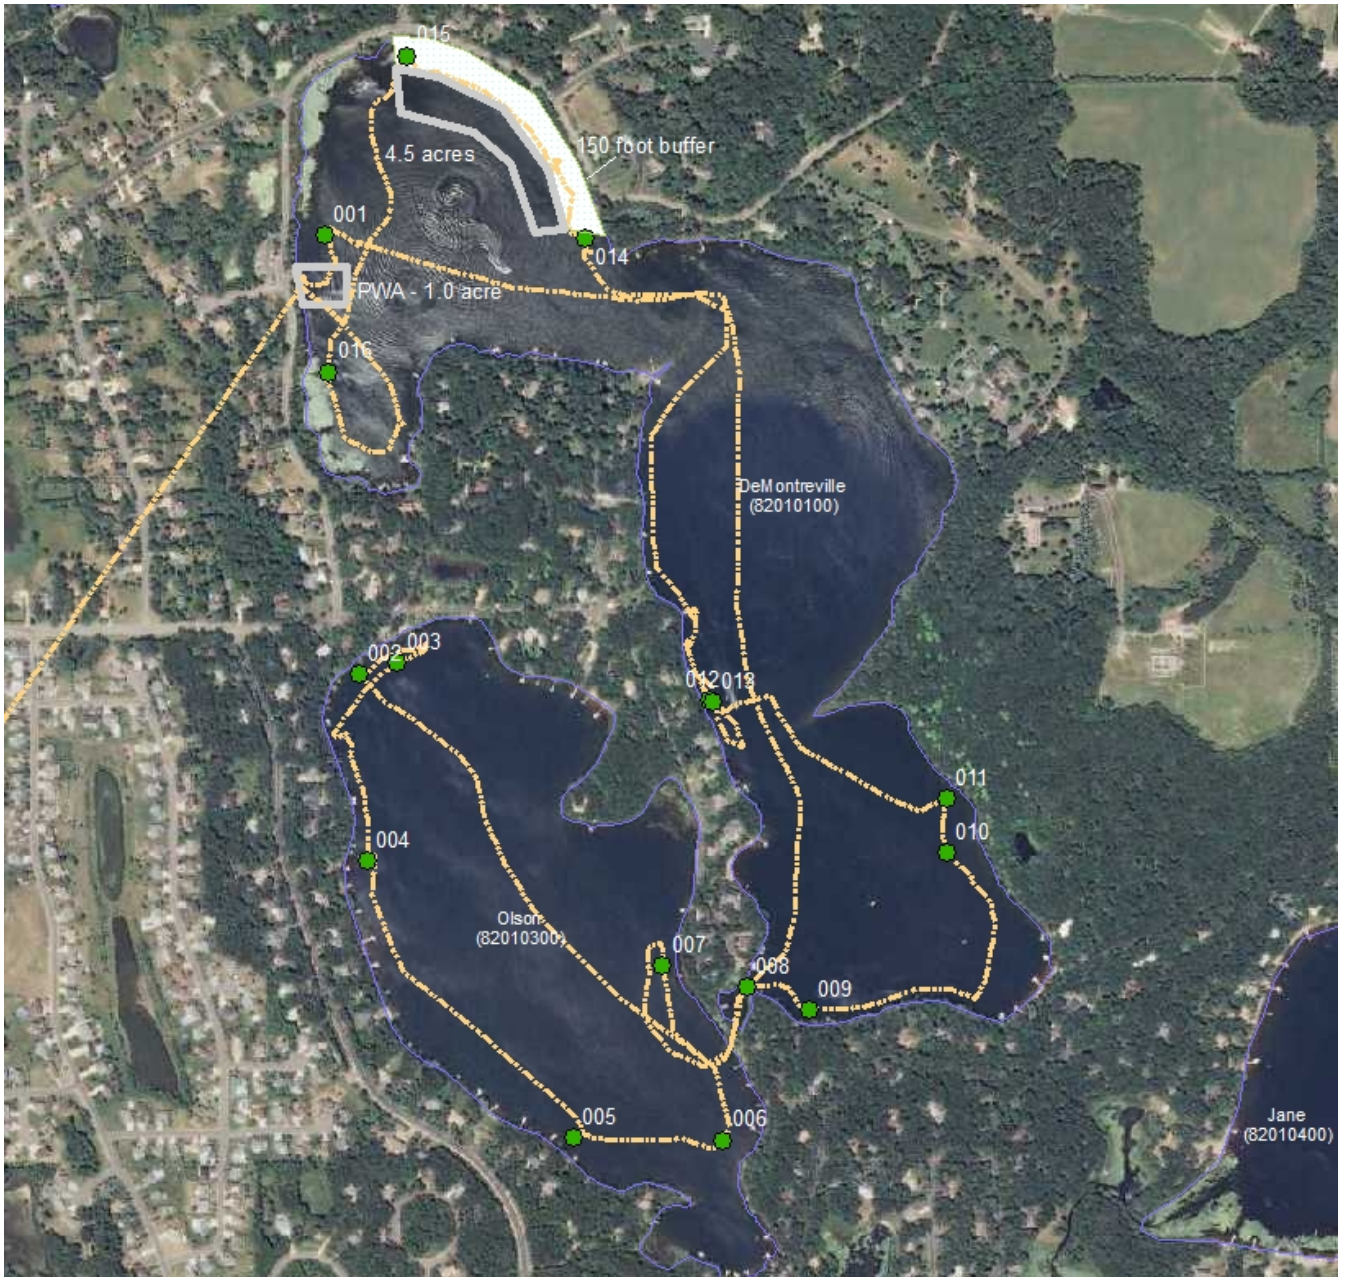
Figure 1: DNR GIS map of the EDRR inspection of Lake Demontreville and Olson. Green dots represent waypoints. The dotted tan line represents the path taken during the survey. Gray polygons approximately encompass areas where EWM treatment is recommended. The light blue polygon is a 150 foot buffer along the NE shore.

Area	Waypoints	Acres proposed	Observations	Recommend that treatment be allowed?	Recommend reimbursement?
Polygon 1 – PWA	Around DNR PWA	1	EWM scattered to common	Yes	Yes
Polygon 2	015-014	Approximately 4.5	EWM common	Yes	Yes

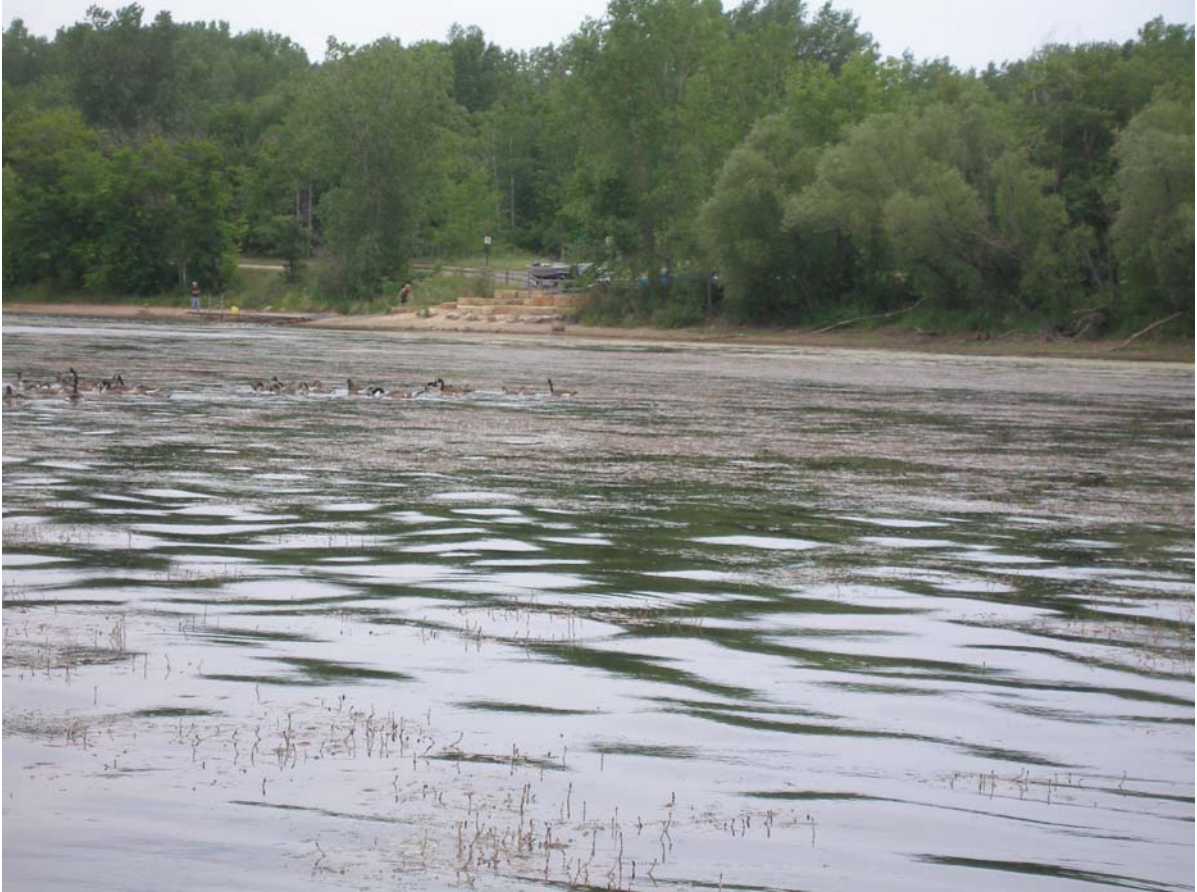
Overall: The main area of EWM infestation is near the boat launch on the upper bay of Lake Demontreville. The infestation area that creates a nuisance (near developed shore) is approximately 4.5 acres. No EWM was found in Lake Olson and only one other small patch (approximately 0.5 acre) was found in Lake Demontreville (near shore, points 012-013). The EWM was found in association with northern watermilfoil, white water crowfoot, flatstem pondweed, and water stargrass. The infestation near the boat launch was adjacent to water lilies and spatterdock. Care should be taken to provide a 25 foot treatment buffer around these plants if treatment is pursued. As a side note, a yellow iris plant (non-native) was observed near point 8 on the shore in the channel between the two lakes. If possible, the landowner should consider removing this plant by digging up the roots and discarding of the plant away from the water body.

Picture 1: Lake Demontreville boat launch area showing matted out EWM.

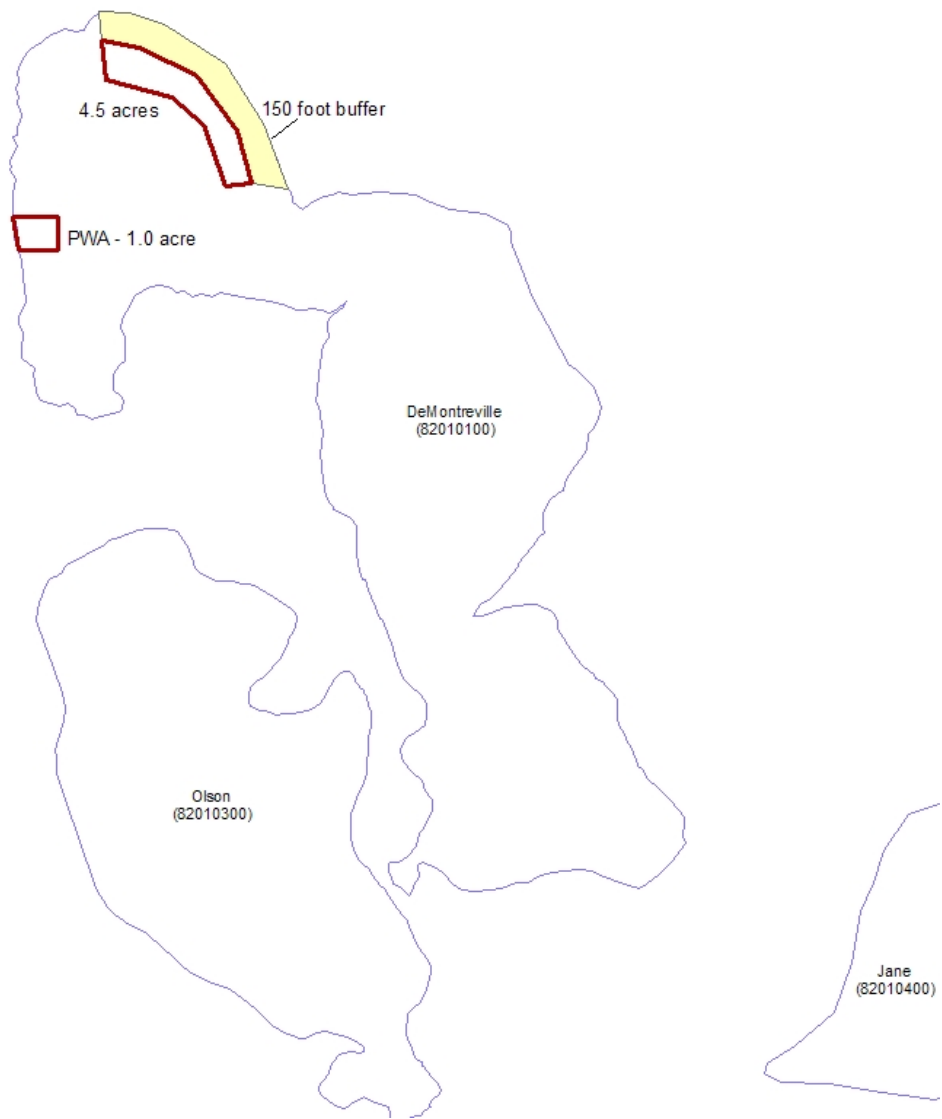
Figure 2: Simple map showing just the recommended treatment areas and the 150 foot buffer along shore.
